MONTHLY NEWSLETTER OF THE PALOS VERDES AMATEUR RADIO CLUB

MAY 2020

Repair of an HF/VHF/UHF Transceiver

By Jerry Kendrick, NG6R

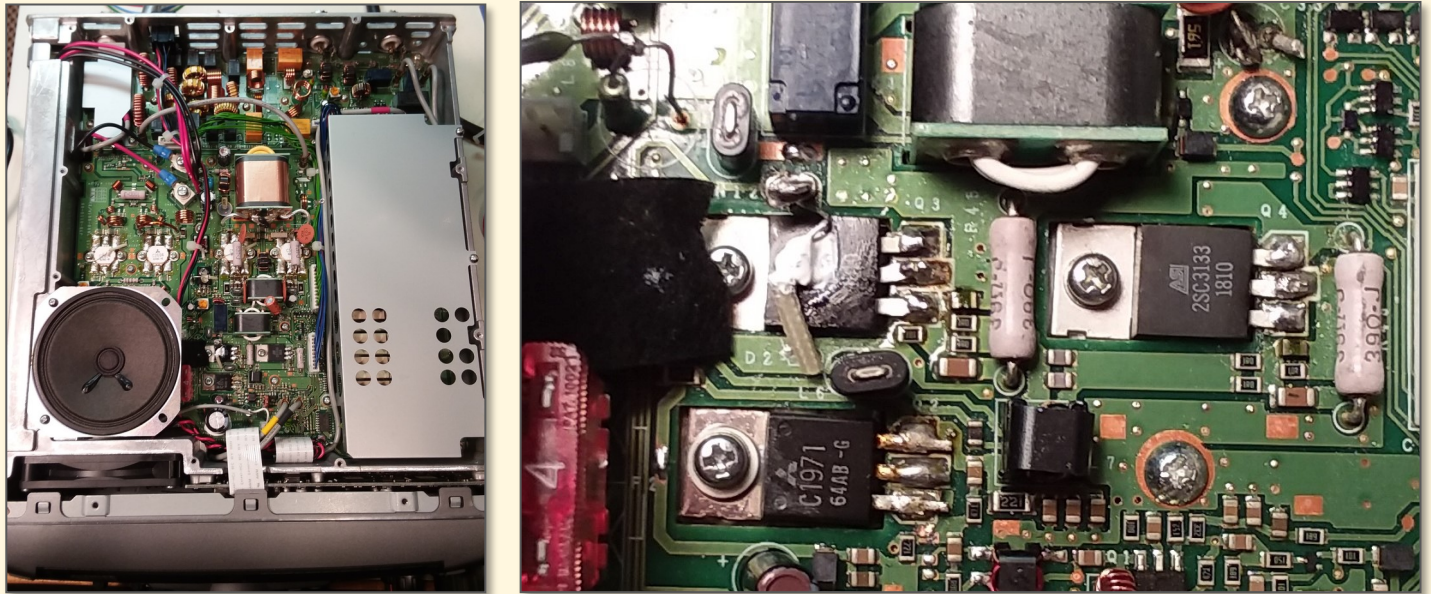
A close-up of the replaced devices is shown in the right photo of Figure 7. The white compound obscuring the labeling on one of the two 2SC3133 transistors envelops a heat sensitive diode (used for thermal compensation and shown as D2 in the lower right corner of Figure 3), re-secured into place with thermally-conductive grease, the same grease placed under the transistors before their emitter tabs were screwed down tightly onto a metal heat sink beneath each transistor.

Figure 7. The two 2SC3133 equivalent replacement transistors have been installed in place of the removed 2SC1972 transistors; the temperature compensation diode was re-secured atop one of the power transistors. PHOTO: JERRY KENDRICK, NG6R

These two 2SC3133 transistors were installed in place of the removed 2SC1972 transistors. The drive voltage to this new pair of drive amplifier transistors was reduced prior to their installation by adjusting the variable resistor VR1, shown near the lower left corner of Figure 3. This VR1 was now adjusted clockwise in TRANSMIT mode to bring the drive voltage on the bases of Q3 and Q4 (2SC3133) up to the 0.74V indicated on the schematic of Figure 3. At this potentiometer setting, output power from the transceiver was measured at just slightly more than 100W, as indicated by the Bird 43 wattmeter. The transceiver was then put through its paces and tested on all bands (HF/VHF/UHF) and in both FM and SSB modes and it performed flawlessly. Of particular interest was any audio distortion that might be created due to potential mismatch in hFE (current gain) between the two new drive amplifier transistors in this push-pull configuration. But, over-the-air audio transmissions on both FM and SSB sounded full and distortion free. **Success!**
